Technical Service Bulletin
4/26/21

Title: Unprotected 12v floor mounted stud terminal

TSB - 015

Models: All 2020-2021 Yetti's with interior's built by Nelson Industries

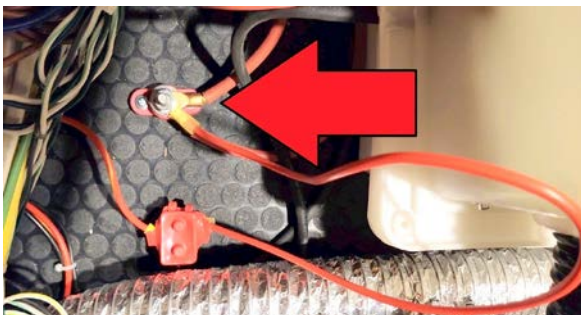
Issue: An unprotected 12v floor mounted stud terminal may allow accidental grounding of this positive circuit. Voyager Industries recommends that customers with units with this condition protect the stud terminal with the free protective cover.

There are many variations of how the electrical systems were installed. This shows the stud terminal in its most common position. If you are uncomfortable performing this installation, please feel free to contact the closest dealer and schedule a service appointment.

In this photo the red arrow points to the positive terminal post for the Yetti's 12-volt system. This connects directly to the positive terminal on the battery on most 2020 – 2021 units with interiors installed by Nelson Industries.

Action: Customers may choose to Install the protective cap onto the stud terminal themselves by requesting a free of charge service kit #51869 ELEC-TERMINAL COVER.

service kit #51869 ELEC-TERMINAL COVER
